Pike River Mine Disaster: Systems-Engineering and Organisational Contributions

Dirk J. Pons

Abstract: The Pike River mine (PRM), an underground coal mine in New Zealand (NZ), exploded in 2010. This paper analyses the causes of the disaster, with a particular focus on the systems engineering and organisational contributions. Poor systems-engineering contributed via poorly designed ventilation, use of power-electronics underground, and placement of the main ventilation fan underground. Management rushed prematurely into production even though the technology development in the mine was incomplete. Investment in non-productive infrastructure was deprioritised resulting in inadequate ventilation, and the lack of a viable second emergency egress. The risk assessments were deficient, incomplete, or not actioned. Warnings and feedback from staff were ignored. Risk arises as a consequence of the complex interactions between the components of the sociotechnical system. Organisations will need to strengthen the integrity of their risk management processes at engineering, management, and board levels. The systems engineering perspective shows the interacting causality between the engineering

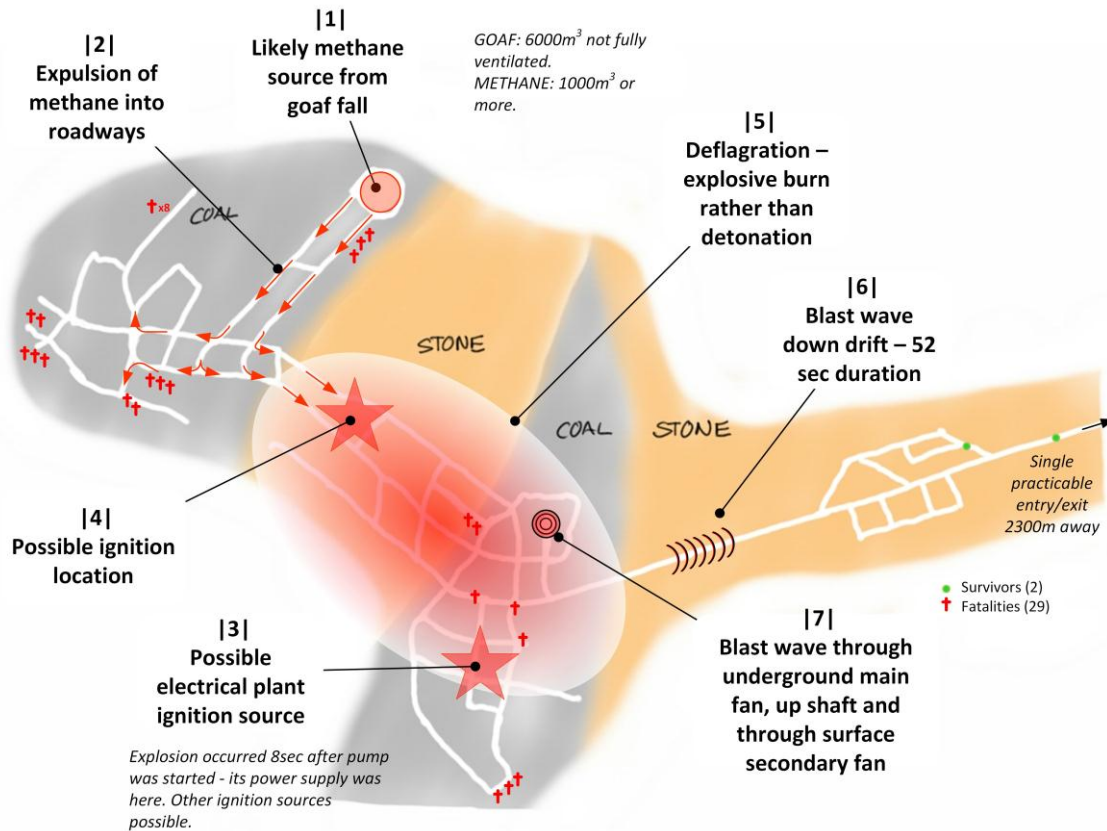
The most likely scenario, represented in Figure 1, was that a large volume of methane gas was produced from the mining activities, at location |1| on the figure. It was a gassy coal-mine, hence prone to liberating methane. Furthermore the hydro-mining (water jet cutting) method was known to cause goaf (roof) falls. These falls not only liberated methane, but also forcibly expelled the gas into the roadways (passages), see |2|. Goaf falls are known to be a significant cause of methane hazard [8].

Figure 1. PIKE RIVER MINE: Layout of mine and possible mechanics of the deflagration. Image D Pons based on images and information in the report of the Royal Commission on the Pike River Coal Mine Tragedy (Te Komihana a te Karauna mo te Parekura Ana Waro o te Awa o Pike) [1].

For an explosion the methane needs to be in the combustible range, and there needs to be an ignition source. There were many possible ignition sources, including electrical hardware, frictional ignition, contraband (cell-phones, watches), and diesel engines. These types of sources have long been known [15] and mines actively manage them by controlling the hardware that is admitted to the mine and the safety procedures. In the case of Pike, the commission could not identify the source with precision. However it was noted that the explosion occurred seconds after electrical power was restored to the pumps, and this coincidence suggested an electrical origin. It is unlikely that the electrical system itself caused the methane to be liberated, as there was reason to believe that the pumps were still only in the start-up phase at the time. Rather, that the methane had previously been liberated, that a goaf fall moved it into the roadways, and that the gas encountered an electrical anomaly in the roadway. It is relevant to note that the mine took an unconventional approach to its electrical system design, described later. An origin of an electrical disturbance within region |3| of the figure is therefore plausible. However other origins are not excluded.

The location of ignition was identified as approximately in region |4| of the figure. This was based on the commission's modelling of the blast propagation using computational flow dynamics (CFD). Similar modelling methods have been applied to other mine explosions [16–18]. The volume of methane combusted was estimated at 1000–6000 m³ and was a burn rather than a detonation as already mentioned. This blast-wave propagated through the roadways and towards the two exits. The main exit path was the inclined drift (tunnel) into the mine, see |6|. This was 2300 m long, a considerable distance especially for emergency egress. The only two survivors were those in the drift, and they experienced a flash of light and an intense and prolonged blast of air that knocked

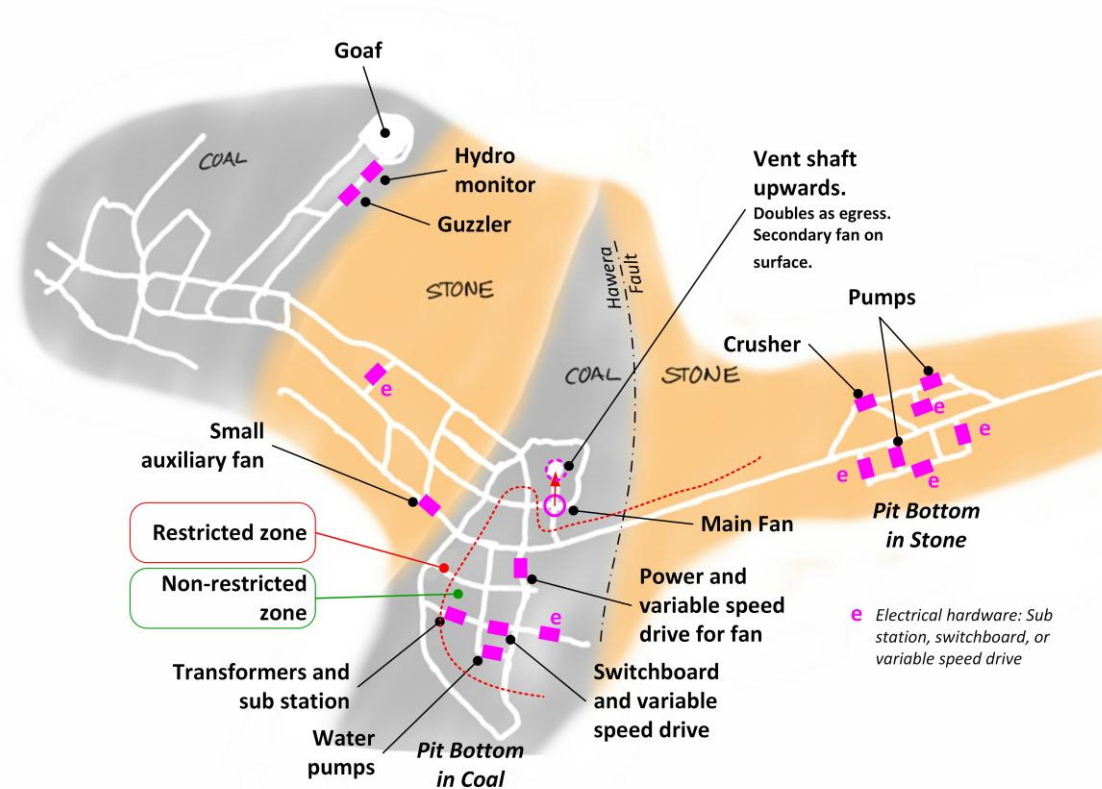
The engineering system design contributed to the accident. The main issues, as shown in Figure 2, were the location of power-electronics hardware, and the ventilation system.

Figure 2. UNCONVENTIONAL SYSTEM DESIGN: The location of electrical hardware was unconventional. Image D Pons based on images and information in the report of the Royal Commission on the Pike River Coal Mine Tragedy (Te Komihana a te Karauna mo te Parekura Ana Waro o te Awa o Pike) [1].

A second location for electrical plant was deeper in the mine, in the coal seam itself, see 'pit bottom in coal', Figure 2. This powered the main ventilation fan and some pumps, including the hydromonitor pump (used for hydro mining) and was supplied by a third 11 kV line along the drift. Selecting this location was unconventional because of the fire and explosion hazard. This was also an imprudent decision given that much of the equipment located here was neither flameproof nor intrinsically safe, and this included the motor for the main ventilation fan. The underlying problem was that Pike defined for itself 'restricted' and 'non-restricted' zones, see Figure 2, based on engineering convenience rather than prudent consideration of the risk. In fact the Royal Commission found there was no risk assessment at all for locating these electrical services in the coal. The restricted zone was where methane was expected and operators were required to take precautions, whereas the non-restricted zone—which included the bit bottom in coal—required no special precautions.

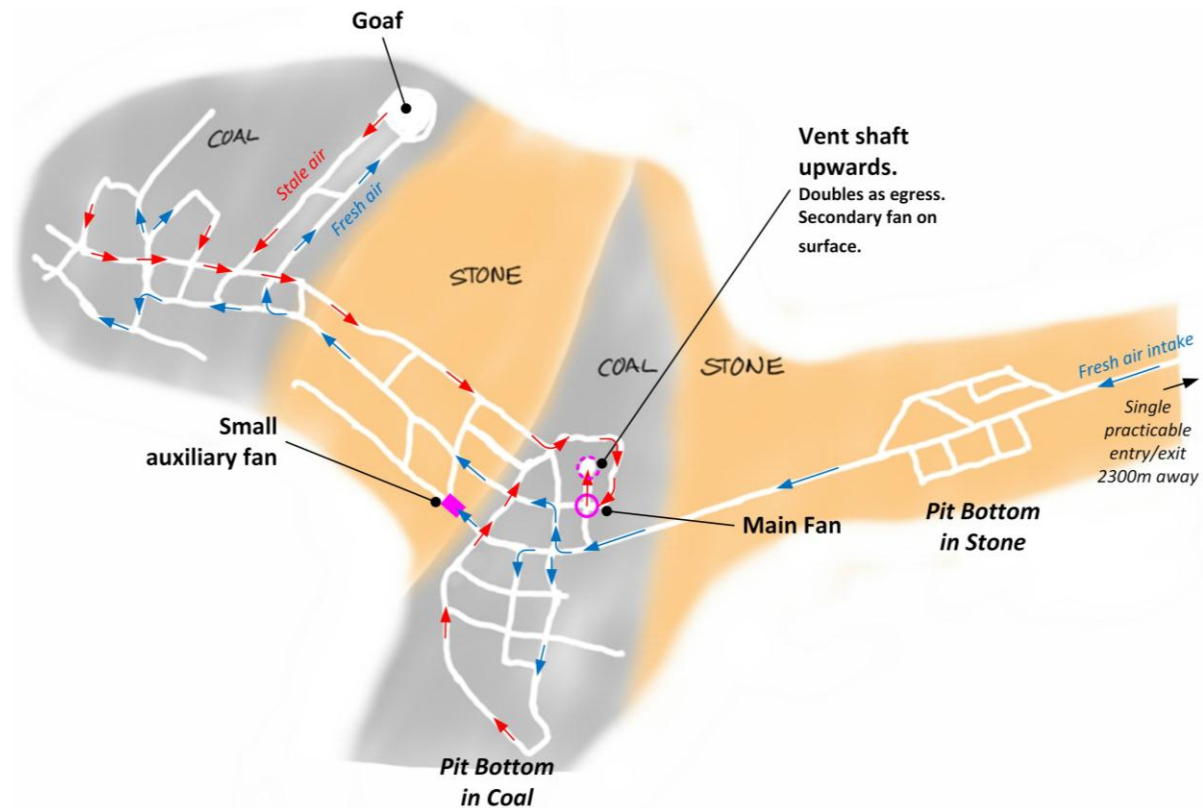
Figure 3. STRETCHED VENTILATION SYSTEM: The system for extracting methane from the mine did not always perform that function adequately. Image D Pons based on images and information in the report of the Royal Commission on the Pike River Coal Mine Tragedy (Te Komihana a te Karauna mo te Parekura Ana Waro o te Awa o Pike) [1].

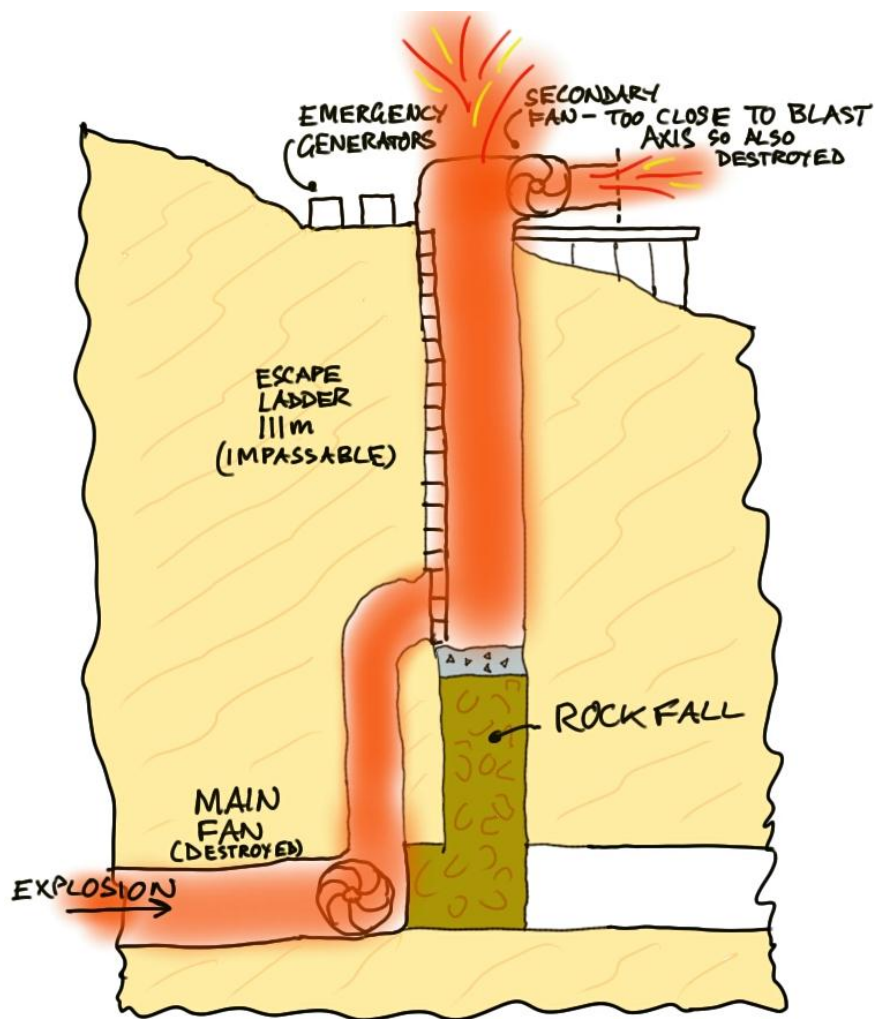
There must also be a secondary fan as an emergency backup. In the case of Pike this was positioned outside the mine, on the top of the ventilation shaft, see Figure 4. This had a lesser airflow capacity to the main fan, and was probably incapable of adequately ventilating the mine except in an emergency. It was located on a hillside deep in the forest, and the only access was by helicopter. It was therefore powered by diesel emergency generators. Unfortunately the design doomed the secondary fan. The blast panels inadequately protected the fan from the over-pressure. These panels were supposed to vent the blast directly to atmosphere, thereby sparing the fan. In defence, the modelling of blasts is not straightforward [22]. Also problematic was that the secondary fan was placed too close to the blast axis of the vent. The first explosion therefore damaged the fan blades, fan housing, generators, and controls. (It is instructive to note that the control panel had been overturned by the blast and struck the emergency stop button of one of two generators). The secondary fan system was sufficiently damaged by the first explosion that it did not function. It could possibly have been repaired, but not immediately and at some safety risk: this was not attempted. The fan and supporting infrastructure was altogether destroyed in the second and subsequent explosions.

Figure 4. BLAST CHIMNEY: The vertical shaft had three *intended* purposes: vent for the main fan, suction path for the secondary fan, and the only other emergency exit from the mine. Its *actual* behaviour was entirely different: it provided a blast path to destroy the main fan, it directed the blast at the secondary fan and so destroyed that too, and it functioned as a chimney of fire which made that route impassable for escape. Note that the rock-fall at the base of the shaft arose during construction, hence the bypass design. Image D Pons.

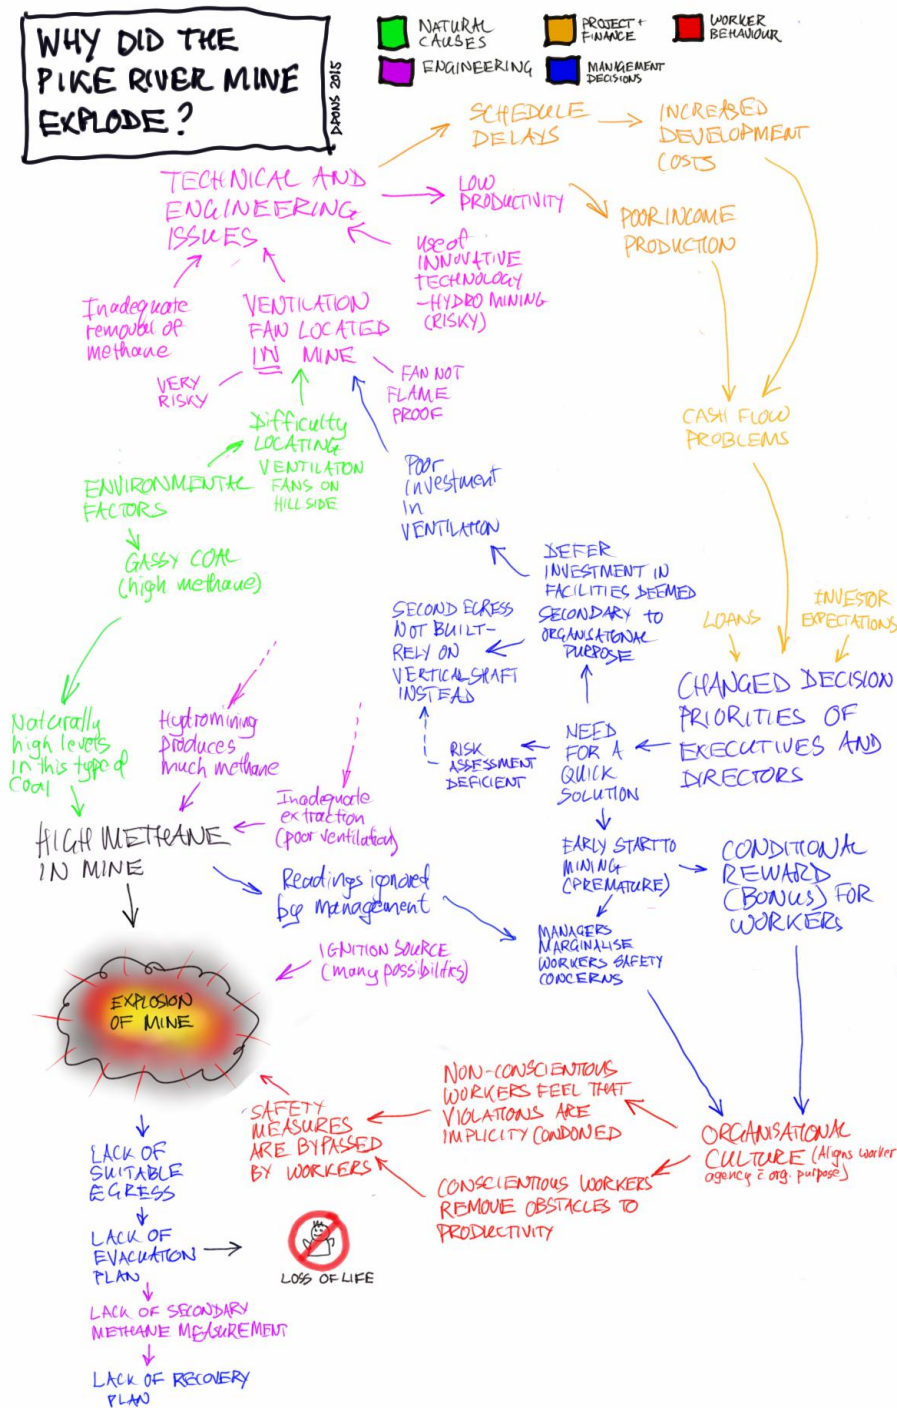
The following diagram shows the complex interplay of these factors: the engineering challenges, project deliverables, management priorities, organisational culture, and workers' behaviour, see Figure 5.

Figure 5. PIKE RIVER MINE: Contributory factors. Image D Pons.

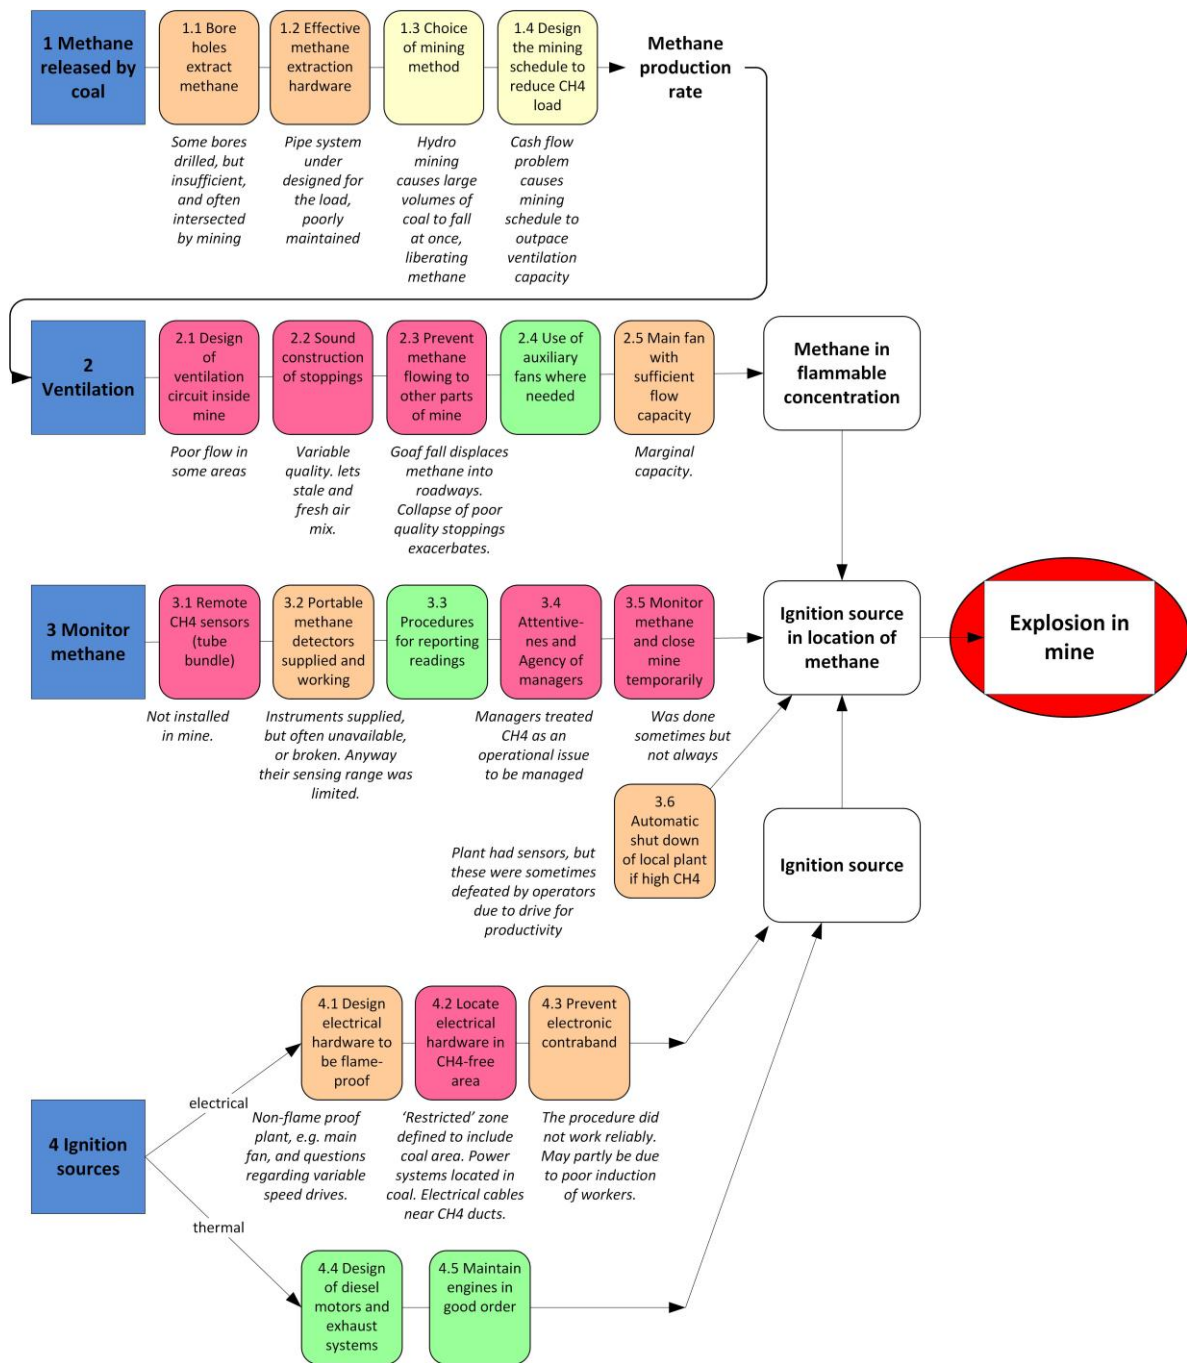
Figure 7. PREVENTION SIDE: PROACTIVE Barriers and Preventative mechanisms for Pike River mine. These are measures which prevent the threat from progressing to an incident. Colours indicate the degree to which the barrier was successful, with red being least successful, and green being generally successful. Colours are assigned subjectively based on a reading of the Commission’s report. Image D Pons.

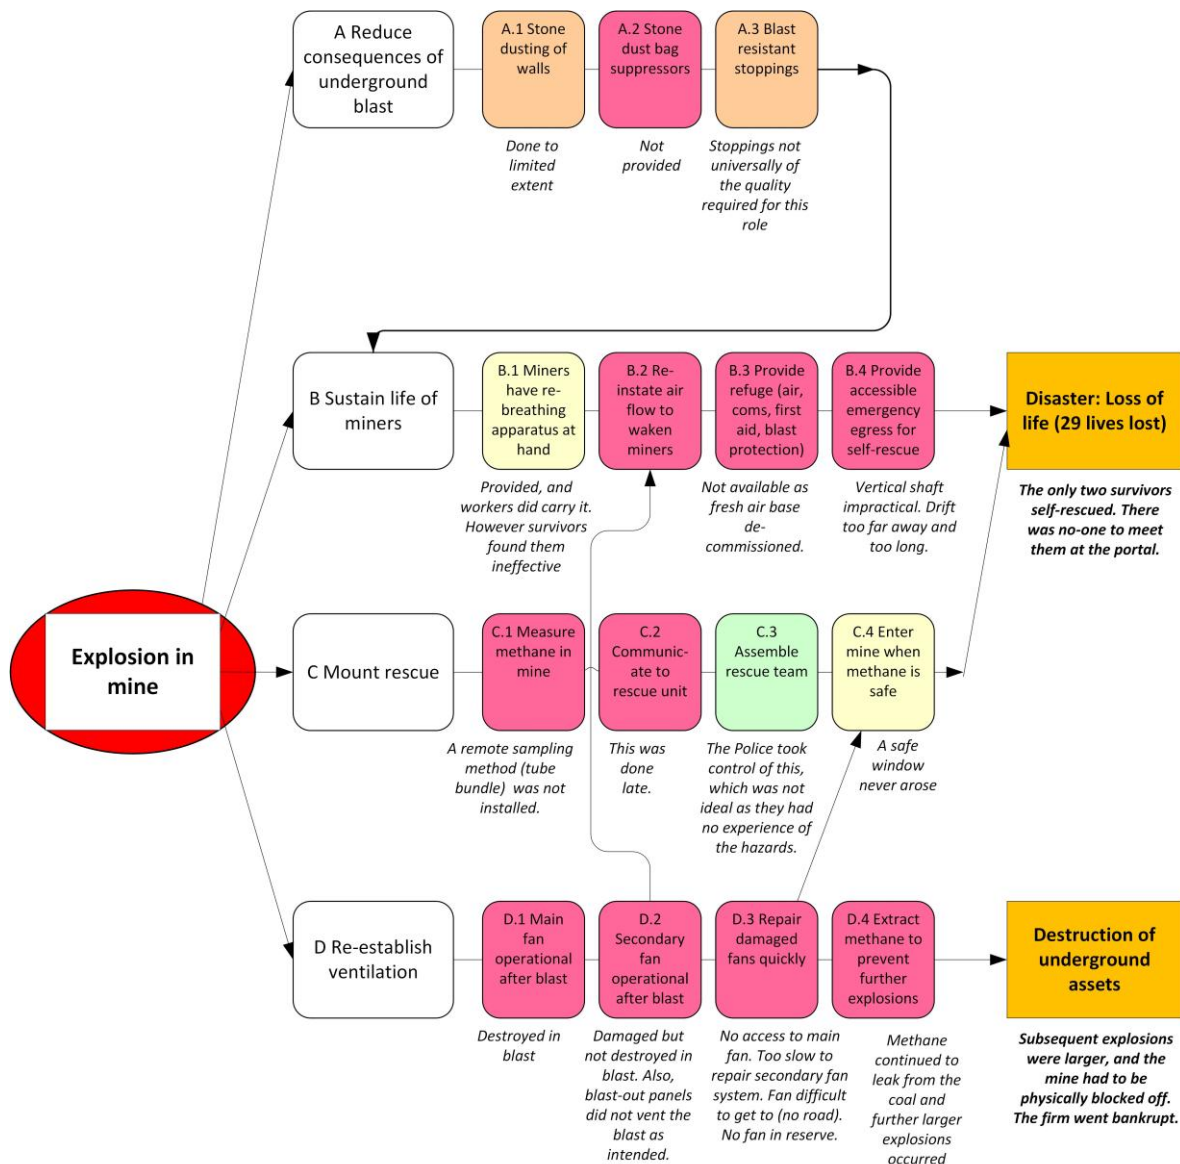
It is evident from the bowtie analysis that re-instatement of the ventilation system was on the critical recovery path. The other recovery activities all depended on it. Realistically, a serious explosion is likely to result in damage to ventilation systems. However the extent of the damage and the rapidity with which ventilation may be re-instated is a variable that is at least partly under the control of the mining company. The controls are affected by engineering design that provides for graceful degradation of technical function, provision of redundancies in key systems, and emergency response procedures that ensure human agency is directed to solving the key problems as quickly as possible. Agency is the ability to exert effort purposefully to achieve an outcome. Pike was poor on all these counts. The design of the ventilation system was vulnerable to an explosion as a common mode failure: the one event overwhelmed both the primary and the secondary fan. They had indeed provided a secondary fan, but its blast doors were too small and the hardware was positioned too close to the blast axis. So the fan, its housing, and its controls, were all damaged. The secondary fan was also under-designed for airflow capacity and hence too small to function as a main ventilation fan. Had it

instead been designed to the same capacity as the main fan, which is not an unreasonable expectation, it would have had larger flow apertures and been significantly more capable of venting the explosion with less damage. Given that the mine had decided to put the main fan underground, this created a critical dependency on the secondary fan. Given also that the secondary fan was located in an area without road access, was known to be under-specified for the task, and was also the emergency egress route from the mine, it really is extraordinary that the design of the secondary fan system was not more robust. This is consistent with Pike’s inadequate risk assessment of its ventilation system. It appears the company had never really thought in an integrated way about how the various hazards intersected and compounded each other. As it was the secondary fan was deemed by some staff to be capable of being repaired after the first explosion. However the response from the emergency managers was slow—agency was not exerted in the direction of reinstating the ventilation—and the subsequent explosions destroyed the fan completely.

Figure 8. CONSEQUENCE SIDE: Recovery mechanisms prevent the undesired state from progressing to further catastrophe. They recover the situation, by reducing either the severity of the consequence, or its likelihood. In Pike’s case the recovery mechanisms were mostly absent or failed. Image D Pons.
