Pike River Mine Disaster: Systems-Engineering and Organisational Contributions

Dirk J. Pons

Abstract: The Pike River mine (PRM), an underground coal mine in New Zealand (NZ), exploded in 2010. This paper analyses the causes of the disaster, with a particular focus on the systems engineering and organisational contributions. Poor systems-engineering contributed via poorly designed ventilation, use of power-electronics underground, and placement of the main ventilation fan underground. Management rushed prematurely into production even though the technology development in the mine was incomplete. Investment in non-productive infrastructure was deprioritised resulting in inadequate ventilation, and the lack of a viable second emergency egress. The risk assessments were deficient, incomplete, or not actioned. Warnings and feedback from staff were ignored. Risk arises as a consequence of the complex interactions between the components of the sociotechnical system. Organisations will need to strengthen the integrity of their risk management processes at engineering, management, and board levels. The systems engineering perspective shows the interacting causality between the engineering

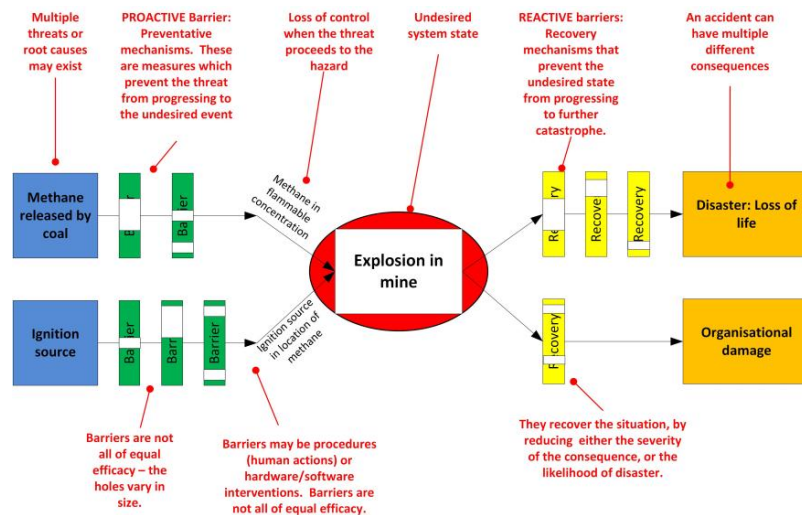
Figure 6. BOWTIE: Multiple THREATS or root causes exist and can, if unchecked, lead to an undesired system state (ACCIDENT), which in turn can progress to a CATASTROPHE. Proactive barrier are the preventative mechanisms which prevent the threat from progressing to a hazard. There is LOSS OF CONTROL when the threat overwhelms or evades the barriers, to cause the accident. Reactive barriers are the recovery mechanisms that prevent the undesired accident state from progressing to further catastrophe. They recover the situation, by reducing either the severity of the consequence, or its likelihood. Image D Pons.

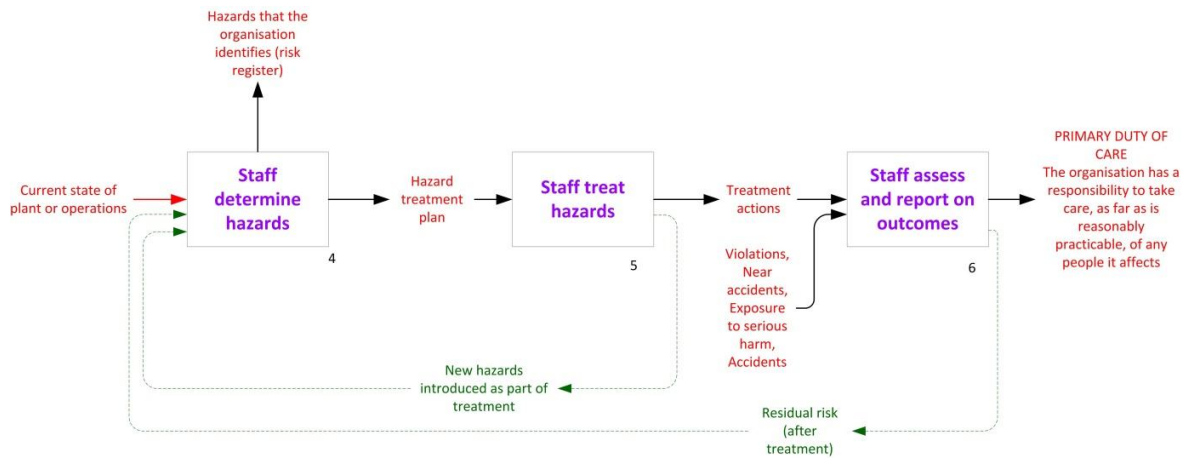
Figure 9. TECHNICAL WORK STREAM: The typical organisational approach to hazards is based on technical staff determining the hazards, treating them, and assessing the outcomes. The process needs to be robust enough to detect when new hazards are introduced as part of treatment, and to assess the residual risk after treatment. Image D Pons.

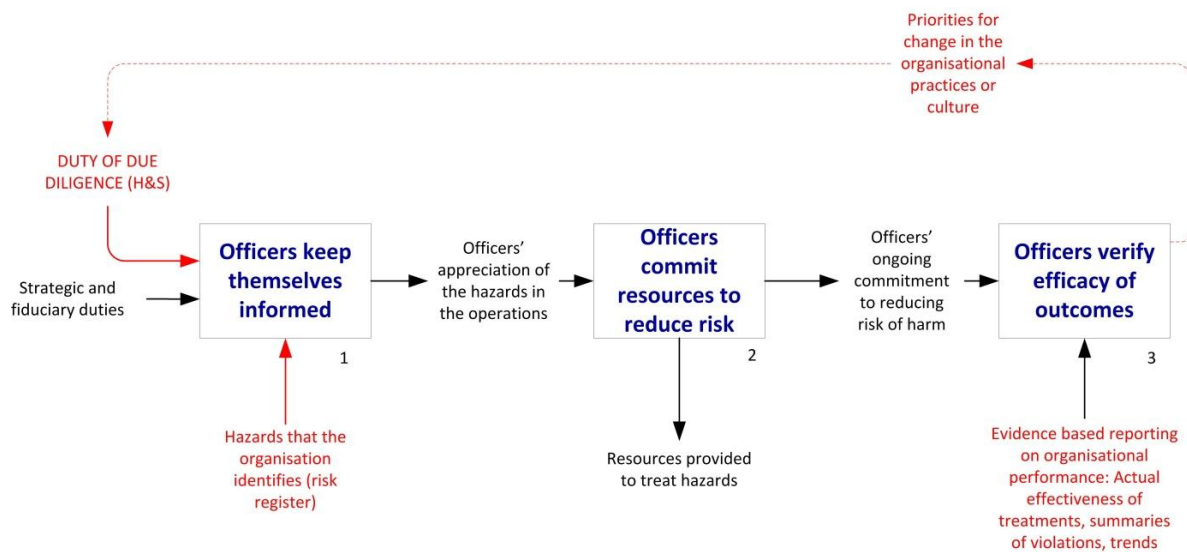
Figure 10. OFFICERS' WORK STREAM: Directors and Executives are now required to keep themselves informed about hazards in their organisation, show ongoing commitment to reduction of harm, and apply diligence to verify the state of the organisation's processes. Image D Pons.

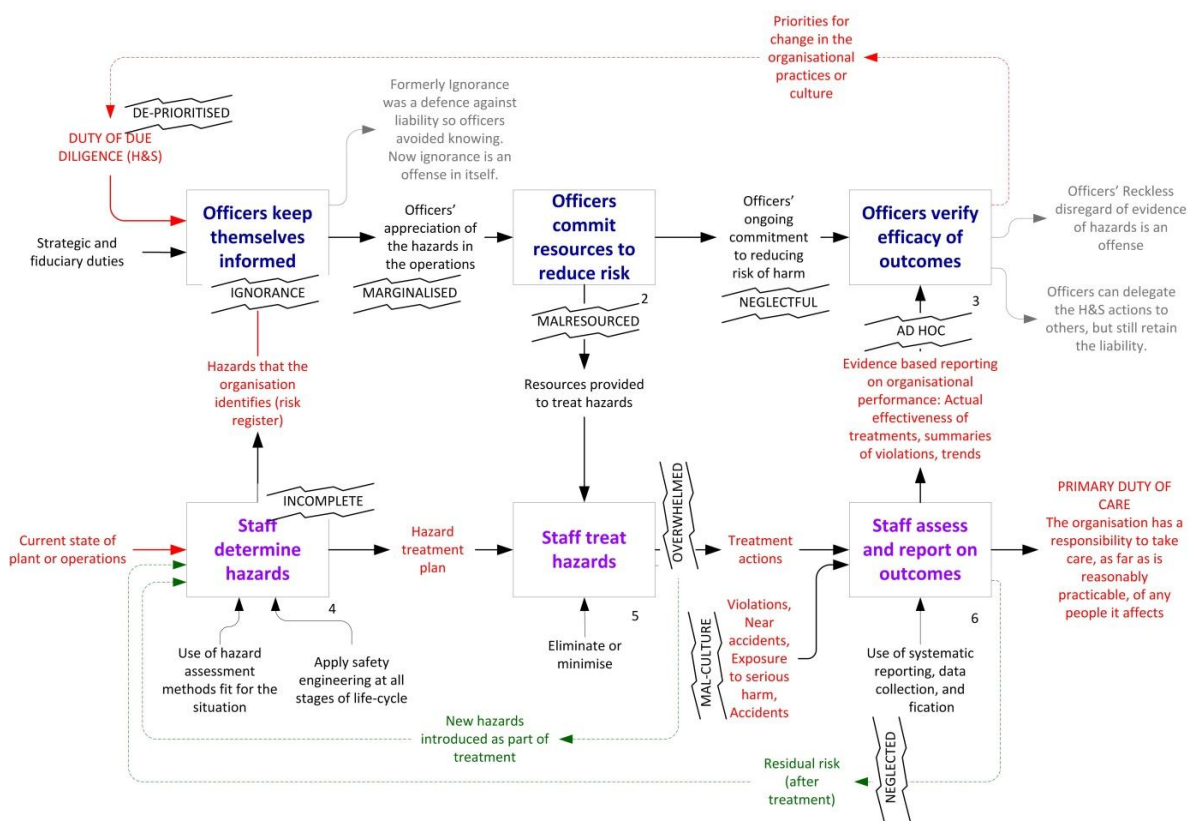
Were a similar accident to occur now, the directors and executives would be exposed to criminal charges for neglecting their duties in multiple areas. The diagram in Figure 11 illustrates some of the common weaknesses: incomplete hazard assessments, under-resourced treatment plans, processes that are overwhelmed by the number of incidents, neglect of introduced and residual risks, poor culture towards violations, ad-hoc or lack of reporting of safety statistics to the board. These are known barriers to effective risk management at the engineering level. Organisations absolutely are expected to be competent at these processes, since the risk assessment process is well-established.

Figure 11. NEW EXPECTATIONS: If a similar accident were to occur now, the directors and executives (‘Officers’) would be guilty on multiple counts, for being negligent regarding their ‘duty of due diligence’ and for failing to ensure that the organisation met its ‘primary duty of care’. Image D Pons.
